A Study on Human, Technical, and Environmental Factors Contributing to the Bell 505 Helicopter Accident in Bali Caused by a Kite String

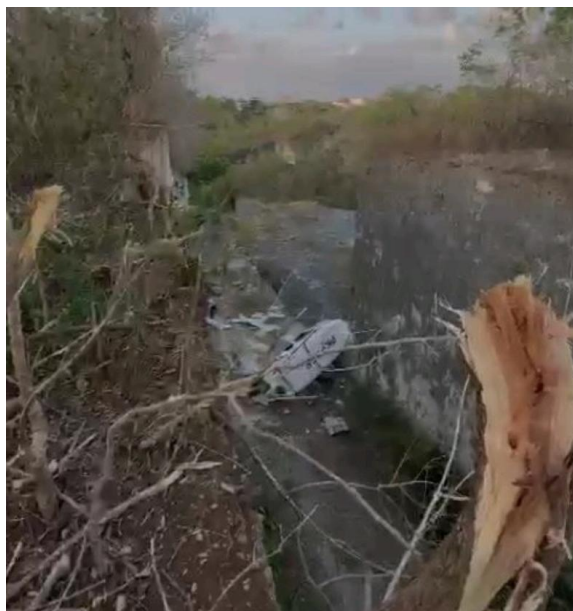
As illustrated in Figure 1 below, the helicopter wreckage was found at the base of a steep limestone ravine in Bali. The terrain characteristics suggest that once control was compromised—potentially due to entanglement with the kite string—the pilot had limited options for recovery, increasing the severity of the outcome.

Figure 1. Aerial view of the helicopter wreckage after it crashed in a steep limestone ravine in Bali, reportedly caused by entanglement with a kite string.

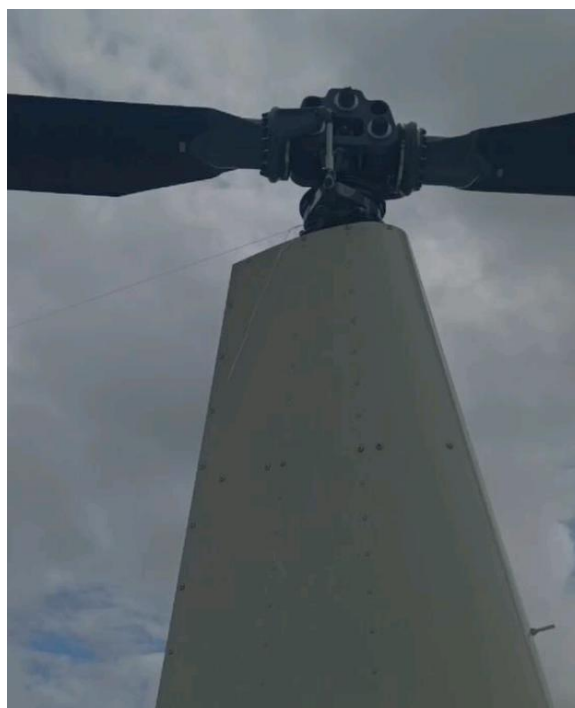
Figure 2. Close-up view of the helicopter's main rotor assembly showing a kite string entangled around the rotor hub structure, identified as a contributing factor in the helicopter crash in Bali.

As shown in Figure 2, the physical evidence recovered from the wreckage demonstrates direct mechanical interference between the kite string and the helicopter's rotor system. The documentation reveals strands of kite string tightly wrapped around the rotor hub and adjacent components, indicating that the aircraft made contact with the string while the rotor was rotating at operational speed. This type of entanglement can immediately disrupt rotor balance, increase aerodynamic drag, and induce severe vibration, potentially leading to loss of control.

The presence of this material firmly attached to critical flight components substantiates the conclusion that the kite string was not merely present in the vicinity but actively interfered with the helicopter's mechanical system. The evidence therefore reinforces the assessment that unauthorized kite flying within or near protected flight paths presents a significant and tangible threat to aviation safety.

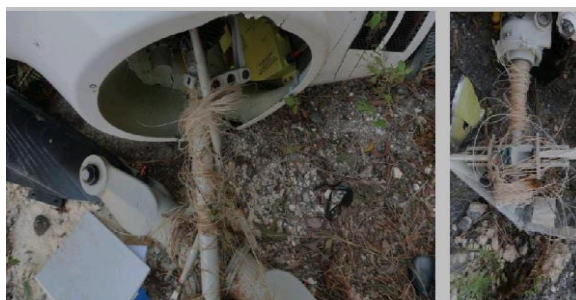
Figure 3. Close-up photographic evidence showing kite string entangled around the helicopter's rotor assembly following the Bali crash, illustrating the direct physical damage caused by the obstruction
