ANALYSIS OF TAXIWAY PAVEMENT CONDITIONS WITH THE PAVEMENT CONDITION INDEX (PCI) METHOD AT JUANDA AIRPORT SURABAYA

Robby Kurniawan*, Bambang Wasito, Wiwid Suryono

Politeknik Penerbangan Surabaya, Jl. Jemur Andayani I No 73 Surabaya 60236

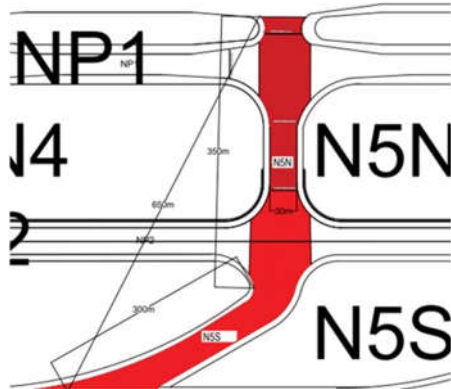
Figure 2. N5N and N5S locations

This method is used to analyze the level of damage to the N5N and N5S taxiway areas. In this analysis, the dimensions of taxiway N5N and N5S that are sampled are 650 meters long and 30 meters wide, for each sample length per 50 meters is taken using the PCI method as shown in the layout below:
