Planning for Runway Pavement Rehabilitation Using the Pavement Condition Index (PCI) Method at Atung Bungsu Airport, Pagar Alam, South Sumatra

Arya Wahyu Dwi Kusumo ¹, Agus Triyono ², Ranatika Purwayudhaningsari ³

^{1,2,3} Politeknik Penerbangan Surabaya

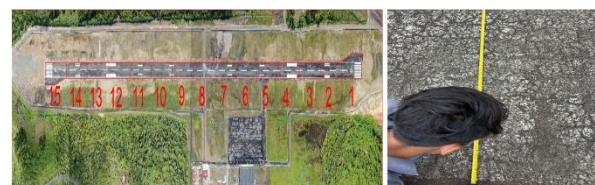
Field survey results indicate that the runway pavement at Atung Bungsu Airport exhibits predominant damage in the form of weathering and raveling across nearly all segments, from STA 0+000 to STA 1+500. The inspection was conducted by dividing the 1,500-meter runway into 15 sample segments, each measuring 100 meters in length and 30 meters in width (see Figure 3). Visual documentation was used to capture the actual surface distress conditions.

Figure 3. Number of Samples (Left); Damage Examples (Right)

Further analysis of each segment indicates that the extent of damage is not entirely uniform. Several segments near the runway threshold, particularly STA 0+000 to STA 0+300, tend to have lower PCI values compared to the central segments. This can be attributed to the threshold area frequently receiving aircraft wheel loads during landing and take-off, where repeated stress accelerates pavement degradation. Additionally, the presence of suboptimal drainage systems along the runway edges allows rainwater to accumulate more easily, exacerbating stripping and aggregate loss.

The Pavement Condition Index (PCI) method was applied to each segment, considering the damage area, severity level, deduct value, and corrected deduct value. The analysis results show that PCI values across nearly all segments fall within the “poor” category, ranging from 30 to 33. Only one segment, STA 1+400 to STA 1+500, recorded a PCI value of 100, classified as “excellent” (see Table 4.31 and Figure 4.33). Therefore, the overall condition of the runway is generally categorized as “poor” and requires immediate corrective action.

Based on the findings, the appropriate repair method refers to KP 94 of 2015 concerning airport pavement maintenance, recommending a 5 cm overlay. This method was selected considering the widespread and severe material loss. Prior to overlay application, the existing surface layer must be cleaned of debris and dust through initial treatment to ensure proper bonding of the new layer.
