# PLANNING OF RUNWAY PAVEMENT REHABILITATION USING THE PAVEMENT CONDITION INDEX (PCI) METHOD AT ATUNG BUNGSU AIRPORT, PAGAR ALAM, SOUTH SUMATRA

## ABSTRACT

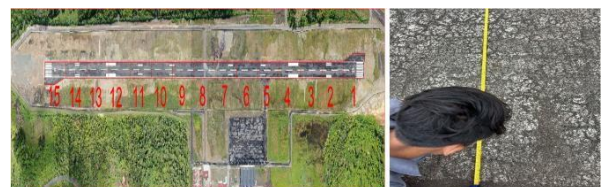
**Figure 3.** Number of Samples (Left); Damage Examples (Right)

Field survey results indicate that the runway pavement at Atung Bungsu Airport exhibits predominant damage in the form of weathering and raveling across nearly all segments, from STA 0+000 to STA 1+500. The inspection was conducted by dividing the 1,500-meter runway into 15 sample segments, each measuring 100 meters in length and 30 meters in width (see Figure 3). Visual documentation was used to capture the actual surface distress conditions.

Further analysis of each segment indicates that the extent of damage is not entirely uniform. Several segments near the runway threshold, particularly STA 0+000 to STA 0+300, tend to have lower PCI values compared to the central segments. This can be attributed to the threshold area frequently receiving aircraft wheel loads during landing and take-off, where repeated stress accelerates pavement degradation. Additionally, the presence of suboptimal drainage systems along the runway edges allows rainwater to accumulate more easily, exacerbating stripping and aggregate loss.

Based on the findings, the appropriate repair method refers to KP 94 of 2015 concerning airport pavement maintenance, recommending a 5 cm overlay. This method was selected considering the widespread and severe material loss. Prior to overlay application, the existing surface layer must be cleaned of debris and dust through initial treatment to ensure proper bonding of the new layer.
