## **Analysis of An MSSR Target Loss Caused By A Tripped Antenna-Motor Rcbo And An Open-Door Sensor Fault During A Lightning-Accompanied Storm**

<sup>1</sup>AirNav Surabaya, Indonesia

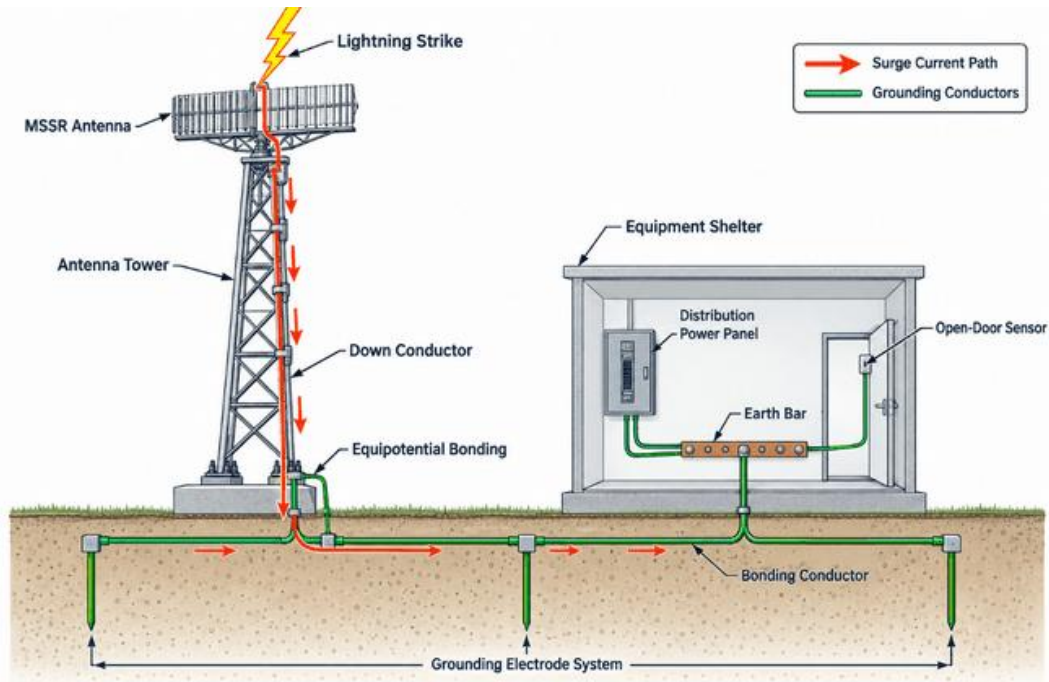
Figure 2 Conceptual Illustration of a Lightning Strike on the MSSR Radar Antenna Shelter and the Open-Door Sensor Protection Path (Source: Authors' conceptual illustration)

Figure 2 presents a conceptual illustration of the lightning-strike path toward the radar antenna structure through to causing a disturbance at the open-door sensor and the distribution power panel inside the shelter, as a visual complement to the explanation of the radar installation's vulnerability to lightning strikes described in the previous section.
