# OPTIMIZATION OF UNIT APRON MOVEMENT CONTROL SUPERVISION FOR THE SUITABILITY OF GROUND SUPPORT EQUIPMENT ON THE AIRSIDE OF AN AIRPORT

## ABSTRACT

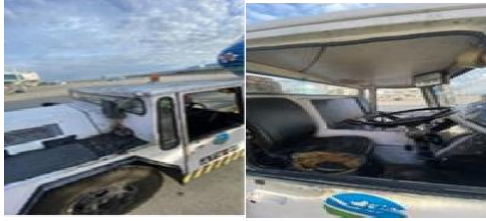
**Figure 3** Rusty Aircraft Towing Tractor at the Parking Stand

2. On December 27, 2023, at Parking Stand 3 in Palu, a significant issue was identified involving Ground Support Equipment (GSE), specifically an aircraft towing tractor (ATT) operated by PT. Global Sky Aviasi. Observations revealed that the ATT was in severe disrepair due to prolonged usage. The vehicle showed extensive rust on its structure, with faded paint indicating insufficient maintenance. Additionally, the seat on the ATT was nearly completely damaged, leaving only the frame. This condition led to significant discomfort for the driver, which could, in turn, affect their focus and performance during operations. The combination of a damaged seat and inadequate maintenance increases the risk of accidents and reduces operational efficiency in the apron area. Therefore, it is crucial to undertake prompt corrective actions, including replacing damaged components and enhancing regular maintenance, to ensure driver safety and comfort while maintaining optimal operational standards.

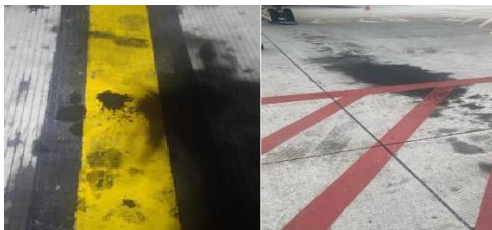
**Figure 4** Oil Drops in Parking Stand 2

3. On December 29, 2023, at Parking Stand 2 at Palu Airport, a leak was detected in a Ground Support Equipment (GSE) unit, specifically an aircraft towing tractor (ATT). Following the completion of a pushback operation, traces of oil were identified, indicating a leakage in the ATT. This incident has several serious implications. Firstly, the oil spill poses a risk of damaging apron facilities, including markings

and the pavement surface, which are essential for supporting efficient airport operations. Secondly, the oil leak creates a significant safety hazard, as the slick surface of the apron increases the likelihood of slipping incidents involving other vehicles and equipment, thereby threatening safety in the apron area. Immediate handling and repair of this leak are crucial to prevent further damage to apron infrastructure and to maintain high safety standards in airport operations. Proactive repair measures, including cleaning the affected area and fixing the leaking equipment, should be undertaken to prevent similar incidents in the future.

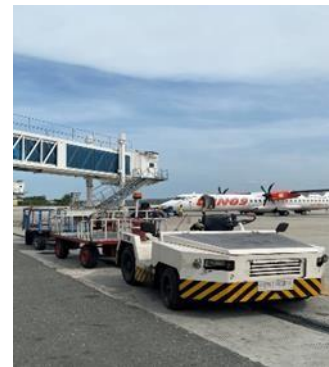
**Figure 5** GSE Damaged While Operating on Service Road

4. On December 26, 2023, an incident involving a Baggage Towing Tractor (BTT) belonging to PT. Global Sky Aviasi was reported at Palu Airport. The BTT unexpectedly halted while attempting to retrieve passenger baggage, causing a delay in operations at the airside. This disruption significantly affected the baggage handling process, resulting in extended waiting times for passengers to receive their luggage. The delay negatively impacted airport operational efficiency and passenger satisfaction. Not only did this incident increase the workload on airport staff, but it also prolonged passenger wait times, potentially diminishing the quality of airport services. Prompt repair of the BTT is essential to ensure smooth operations and mitigate adverse effects on passengers. Enhanced maintenance practices and routine inspections of Ground Support Equipment (GSE) are necessary to minimize the risk of similar incidents in the future and to improve both operational efficiency and passenger experience at the airport.
