THE EFFECT OF *STOP LINE* MARKINGS ON THE SAFETY OF AIRCRAFT MOVEMENT ON THE *APRON*

Abstract

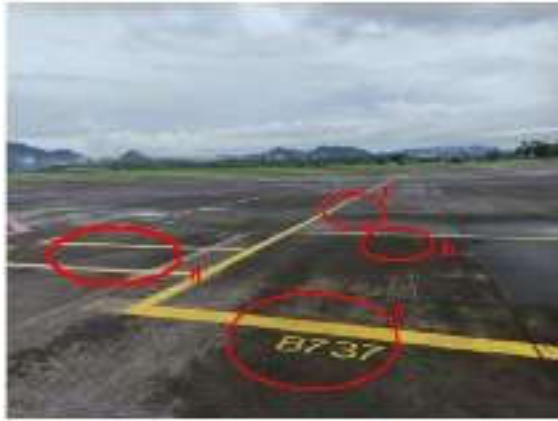
Figure 2 Analysis of problems at parking stand 8

On parking stand 8, there are stop line markings that do not have identification as in points **b** and **c** and also one stop line mark with identification B737 but in placement that is not appropriate in actual conditions as shown in point **a**.

The literature study conducted by the author found that the problem at parking stand 8 was not in accordance with the applicable regulations, namely ICAO Doc. 9157 [5] point 2.3.18 and also Annex 14 – Aerodromes [4] point 5.2.13.10. The regulation explains that if an aircraft stand is used by two or three types of aircraft, identification according to aircraft type is required.

The recommendation to solve the problem in accordance with the regulation is in point a indicated by **Figure 2** by temporarily closing the B737 aircraft type designation mark on the first stop line using cloth tape for then removing the mark and repainting according to the type of aircraft needed. In point b, painting the new aircraft type designation mark for the B737/A320 aircraft type on the second stop line in accordance with the actual conditions of the use of the stop line. In point c can remove the third stop line mark or add a new aircraft type designation mark according to the type of aircraft needed.

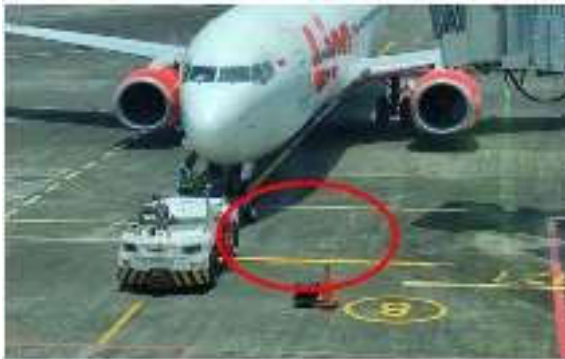
Figure 3 Parking of B737-900 aircraft does not match the actual stop line

This is supported by evidence of the findings of LionAir aircraft with registration PK-LJG type B737-900 aircraft parked on a stop line that did not have identification.

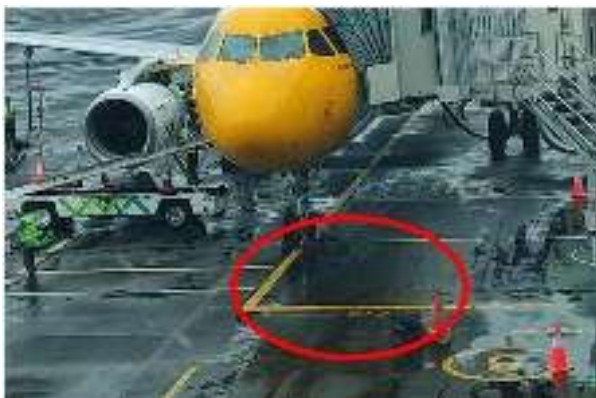
The author also found a Scoot airline aircraft with flight number TR-216 registered 9V-TRW type A320 aircraft equivalent to B737 parked (*block on*) on a stop line that did not have identification.

This proves that the stop line identification for the B737/A320 is not in its actual place according to actual conditions.

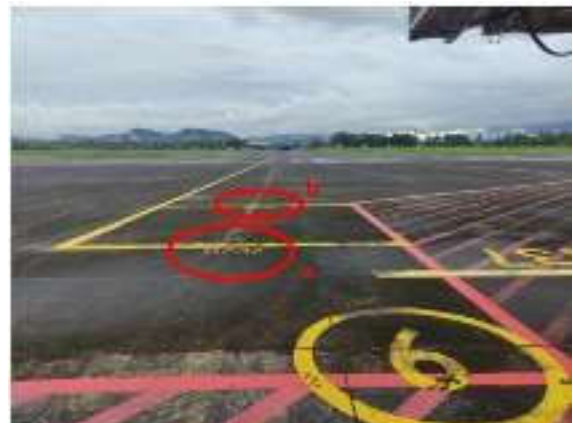
Figure 4 Analysis of problems at parking stand 9

On parking stand 9 found two stop line marshaller markings that have the same aircraft type design (B737). Two stop lines made on one aircraft stand are intended for several different aircraft types so that both stop lines

must be given identification of aircraft types according to their type to ensure the safety of aircraft movement to aircraft facilities such as laying aerobridges.

Recommendations for solving the problem in accordance with the regulations, point A indicated by **Figure 4** by temporarily closing the B737 aircraft type designation markings on the first stop line using cloth tape for then removing markings and repainting according to the type of aircraft needed. In point b, repaint the aircraft type designation markings for the B737/A320 aircraft type on the second stop line according to actual conditions.

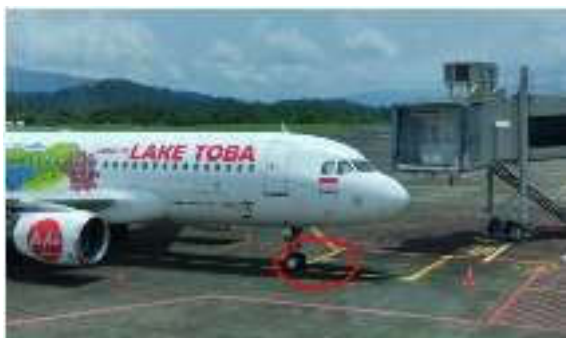
Figure 5 Parking of the A320 aircraft at parking stand 9

The author found that an AirAsia aircraft with registration PK-AZR with type A320 parked at parking stand 9 on the second stop line so that the first stop line was not suitable for type B737/A320 aircraft and had to be reidentified.
