# THE INFLUENCE OF THE CONDITION OF AIRSIDE PARAMETER FENCE FACILITIES ON FLIGHT SECURITY AND SAFETY AT KUPANG EL TARI INTERNATIONAL AIRPORT

<sup>1,2,3</sup> Civil Aviation Polytechnic Surabaya

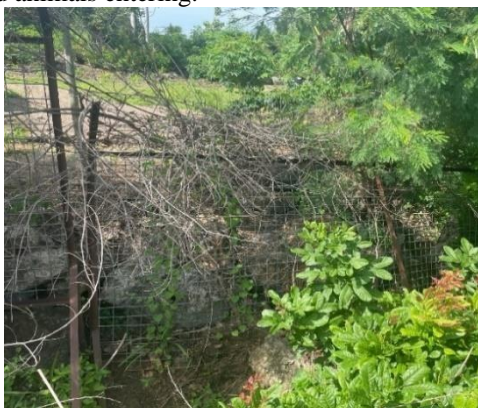
The condition of the perimeter fence at El Tari International Airport in Kupang, which does not meet the standards—such as having holes or gaps that are not properly sealed—can lead to incidents and accidents. Intruders and animals may enter the airport's airside area, which is supposed to be restricted, due to these gaps in the perimeter fence. This not only disrupts operational activities but can also lead to unwanted incidents or even result in loss of life. Therefore, the airport must repair the perimeter fence to maintain the airport's image and ensure the safety and comfort of both flights and passengers.

Figure 1. Perimeter Fence at El Tari International Airport in Kupang That Does Not Meet Standards  
Source: Researcher's Analysis (2024)

The researcher identified sections of the perimeter fence that do not meet the minimum height requirement of 2.44 meters as stipulated in the regulations. This shortcoming poses a significant risk, as it could potentially allow unauthorized individuals to breach the Security Restricted Area (SRA) with relative ease.

Based on the discussion above, it can be concluded that the condition of the perimeter fence facilities has a significant impact on the security and safety of flights at El Tari Kupang International Airport. This is supported by the results of the correlation test between the condition of the perimeter fence and the level of security and safety, where a correlation value of 0.735 indicates a strong relationship between the two. However, the condition of the perimeter fence facilities at El Tari Kupang International Airport does not yet fully comply with the standards set out in KM 39 of 2024 concerning the National Aviation Security Program. Observations show that there are still requirements that have not been met regarding the condition of the perimeter fence facilities at the airport. Therefore, the researcher offers several suggestions for improvement at El Tari Kupang International Airport. First, regular maintenance and upkeep of the perimeter fence facilities are necessary, especially to address the issue of wild plants that grow and cause damage, which can become an entry path for living creatures into the Security Restricted Area, potentially leading to accidents. Second, it is

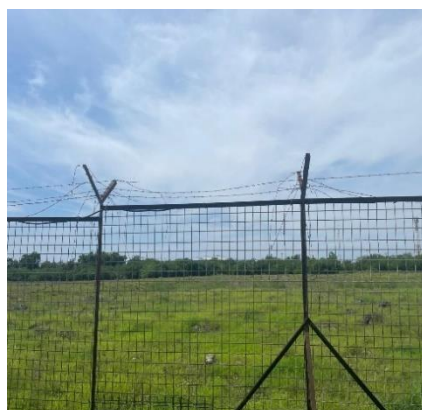
Figure 2. Condition of the Barbed Wire on the Perimeter Fence at El Tari International Airport in Kupang  
Source: Researcher's Analysis (2024)

It was observed that some areas of the perimeter fence had gaps in the barbed wire. The barbed wire is intended to prevent the entry of unauthorized individuals and wildlife into the SRA. However, these gaps compromise the fence's effectiveness, making it easier for breaches to occur.

recommended to install barbed wire evenly at all points of the perimeter fence facilities that do not yet meet standards, as an effective measure to prevent living creatures from entering the Security Restricted Area. Third, the installation of lighting and Closed Circuit Television (CCTV) should be done evenly across the perimeter fence facilities. Lighting and CCTV must function optimally, as if one of them is not working properly, the security system will weaken and become vulnerable to intrusion.
