# ANALYSIS OF EQUIPMENT STORAGE AREA MANAGEMENT IN SUPPORTING OPERATIONAL SAFETY AT EL TARI KUPANG AIRPORT

## ABSTRACT

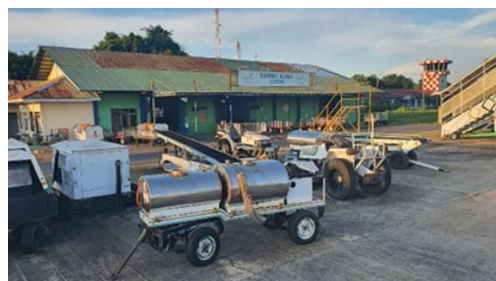
Observations conducted in the Equipment Storage Area revealed that the placement of Ground

Support Equipment (GSE) is still not well organized. The GSE units are placed in the ESA without any specific pattern, and often block the movement paths of other vehicles. The absence of markings or boundary lines results in a cluttered storage area that is inefficient in supporting smooth apron operations.

**Figure 1.** Ground Support Equipment are obstructing each other

Markings were installed in the Equipment Storage Area to improve layout organization and enhance orderliness in the storage and retrieval process of Ground Support Equipment (GSE). The left Equipment Storage Area measures 35 meters in length and 15.4 meters in width, while the right Equipment Storage Area measures 178 meters in length and 15.4 meters in width. Between the left and right storage areas, there is an 8-meter-wide access road leading to the cargo terminal.

The markings were designed in accordance with the Directorate General of Civil Aviation Regulation No. PR 21 of 2023 concerning Technical and Operational Standards for Civil Aviation Safety Regulations Part 139 (Manual of Standard CASR Part 139) Volume I – Land Aerodromes, which stipulates that the words “EQUIPMENT STORAGE” must be painted in red with a letter height of 0.3 meters and positioned 0.15 meters from an unbroken red line 0.1 meters wide. These markings are intended to provide clear visual guidance for ground handling personnel in arranging GSE, while also serving as an official boundary to prevent equipment from encroaching onto stand areas or taxiways.

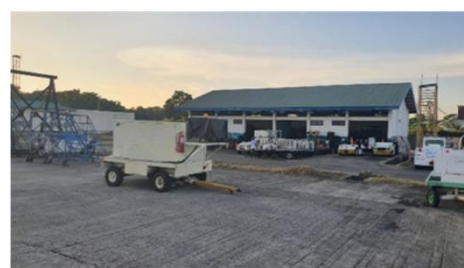
In interviews with ground handling personnel, they stated that the current placement or storage of equipment is based on the available empty space and the work habits of each shift. As a result, during shift changes, equipment placed by the previous team is often difficult for the next team to locate or access. The lack of visual guidelines makes overlapping equipment placement unavoidable, especially during peak flight hours.

**Figure 2.** Ground Support Equipment is placed irregularly

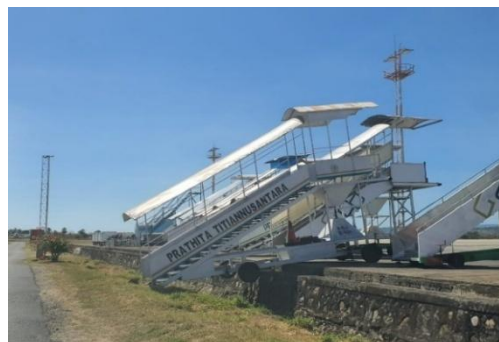
In addition to the lack of supporting infrastructure in the form of permanent physical barriers, it was also found that ground handling personnel do not consistently install wheel chocks on GSE units stored in the area. This indicates the occurrence of human error in the implementation of occupational safety procedures in the field. This is despite the fact that the airport management routinely conducts safety procedure briefings for all ground handling personnel. Furthermore, ramp checks are carried out periodically every three

**Figure 4.** The passenger boarding stairs fell off

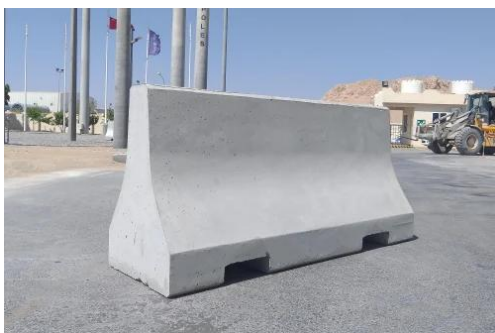
**Figure 5. Concrete Barrier**

The installation of permanent concrete barriers, as illustrated in the figure, provides an effective physical solution to minimize the risk of

uncontrolled GSE movement. With the implementation of these barriers, incidents of GSE sliding into the drainage channel—especially when unattended and without wheel chocks—can be prevented. The proposed barrier design features dimensions of 200 cm in length, 80 cm in height, and 60 cm in width. The concrete barriers will be installed closely in a continuous row to form a solid protective line along the side of the ESA that directly borders the drainage channel. With the total length of the ESA's rear side being approximately 213 meters (combined length of both left and right ESAs), around 107 units of concrete barriers, each 2 meters long, will be required. Installation will be adjusted to follow the surface contour of the ESA to ensure maximum protection.

These barriers will also function as the final parking limit, providing ground handling personnel with a clear visual reference for arranging equipment safely and orderly. Concrete was chosen as the material due to its high durability against pressure and extreme weather conditions, which are common in open-air airport environments. Therefore, the implementation of permanent concrete barriers in the ESA should be prioritized as a preventive measure to support operational safety standards.

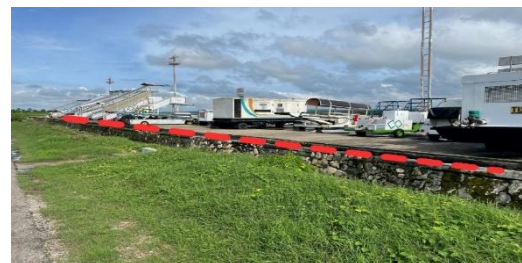
**Figure 3. Permanent Concrete Barrier Installation Area**

2. El Tari Airport Kupang should promptly install permanent concrete barriers along the boundary of the Equipment Storage Area adjacent to the drainage channel. This installation aims to serve as a physical safeguard to prevent equipment from slipping. Additionally, it is recommended that El Tari Airport Kupang and ground handling companies jointly draft and implement a Letter of Operational Coordination Agreement (LOCA). This document will serve as a formal basis for establishing operational coordination, sharing safety responsibilities in the Equipment Storage Area, and clarifying communication channels between parties. With the LOCA in place, information sharing, issue reporting, and follow-
