## **Diagnosis And Handling Of A Coil Failure On A Handheld Metal Detector As An Aviation Security Facility**

The Handheld Metal Detector (HMD) is an aviation security (AVSEC) facility used for secondary passenger screening to detect metal objects that may endanger flight safety. On 10 February 2025, the HMD at Security Check Point 2 (SCP 2), Terminal 1A of Soekarno-Hatta International Airport, malfunctioned and could no longer emit electromagnetic waves, rendering it unable to detect metal. This article aims to analyze the cause of the malfunction and document the repair process. The method used was field observation and systematic troubleshooting, consisting of disassembling the unit, inspecting the physical modules, measuring battery voltage, checking the continuity of the power supply line using a digital avometer, and testing the metal-detecting coil. The analysis revealed that the battery and power supply line were functioning normally, while, by elimination, the damage was located in the coil, which no longer produced an electromagnetic field. The repair was carried out by replacing the coil with a component taken from another unused HMD unit, soldering it to the module, an

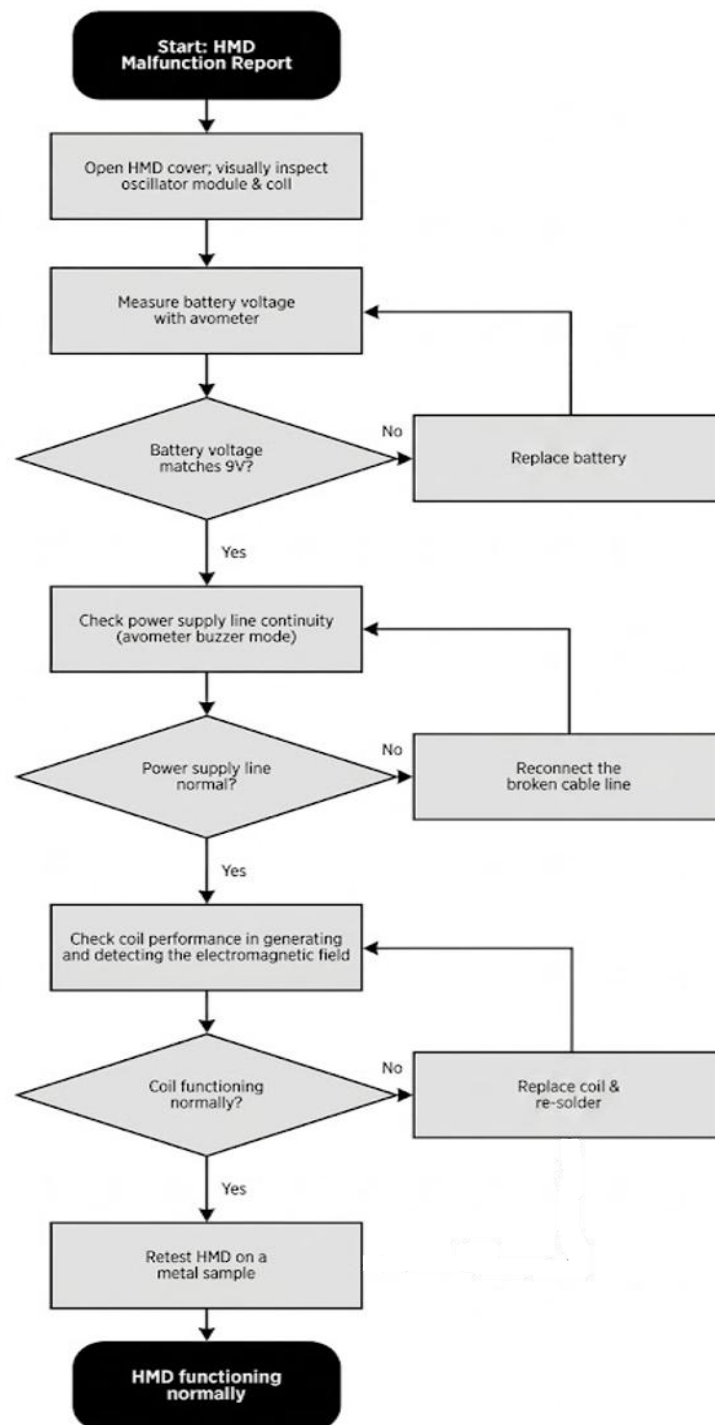
Figure 1 Flowchart of the HMD Damage Diagnosis and Handling Process (Source: Processed by the Authors, 2025)

Figure 1 presents a flowchart that systematically summarizes the entire diagnostic process, beginning with the visual inspection of components, battery voltage measurement, power-supply-line check, and coil testing, together with the handling step at each decision point, up to the final post-repair verification.

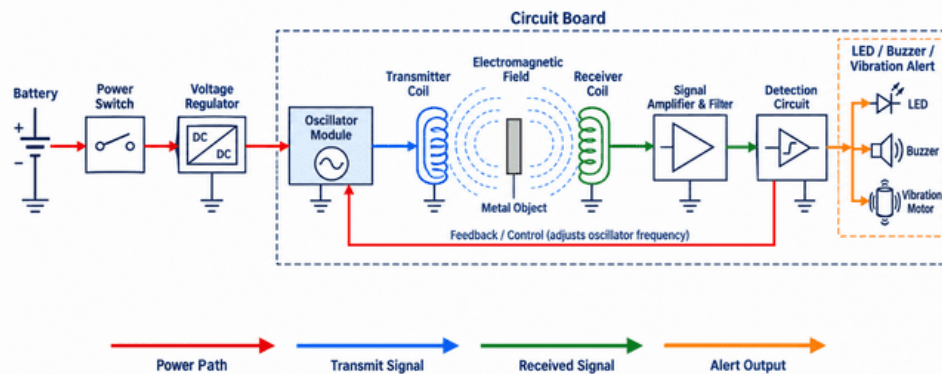
Figure 2 Conceptual Illustration of the Handheld Metal Detector (HMD) in Aviation Security Screening

Figure 2 presents a conceptual illustration of the Handheld Metal Detector (HMD), showing the physical form of the device and the position of its main components, namely the coil and the oscillator module, as a visual complement to the explanation of the HMD's working principle described in the previous section.
