## **Analysis of the Malfunction and Handling of the Navtech Radar in an Airport Perimeter Security System**

The Navtech AdvanceGuard radar is a core component of the Perimeter Intruder Detection System (PIDS) that monitors and detects object movement along the perimeter area of Juanda International Airport, Surabaya, integrated with Pan/Tilt/Zoom (PTZ) cameras for automatic visual tracking. During the study period, Aviation Security (AVSEC) officers reported that the Navtech radar was not functioning. This article aims to analyze the cause of the malfunction and document the repair process. The method used was field observation and systematic troubleshooting, consisting of checking the radar status through the monitoring application, measuring the power supply, and testing the camera cabling network. The initial inspection showed the radar status as red (off) due to a malfunctioning power supply, which also caused the network indicator on the switch to go dark; replacing the power supply restored the radar to normal (running) status. However, further verification found that the PTZ camera could not follow the radar's commands due to corrosion on the RJ45 connector of the camera c

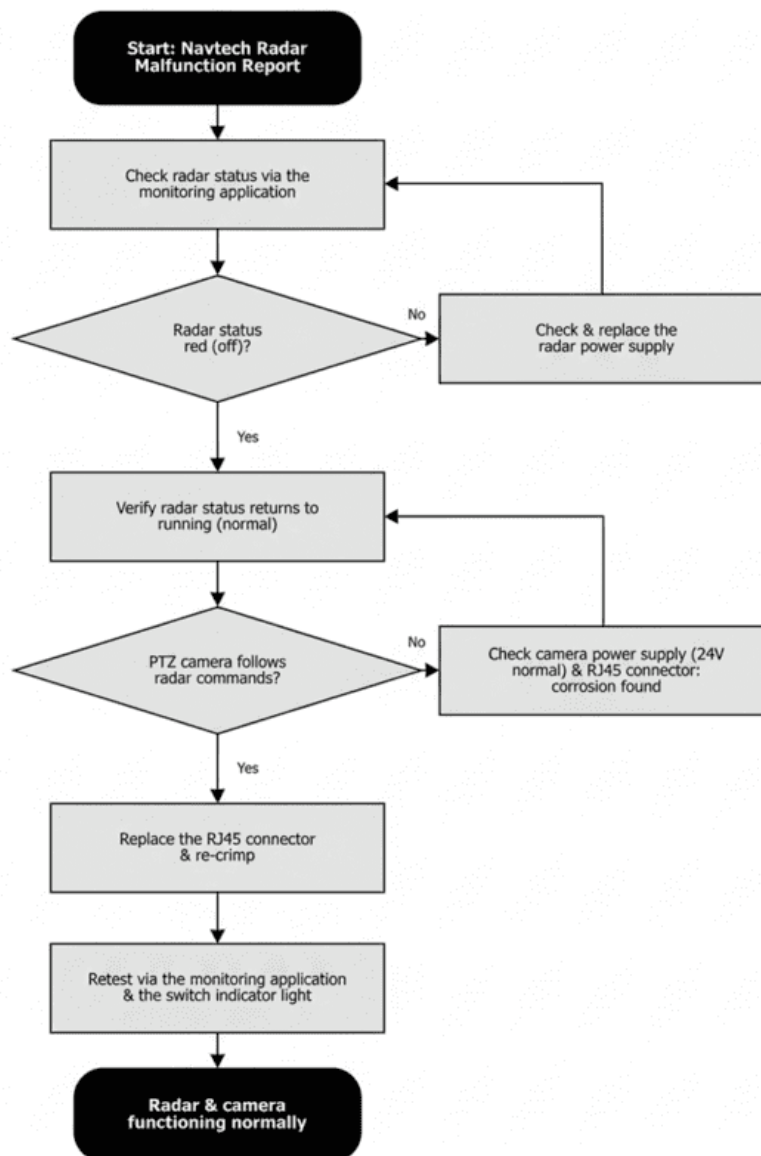
Figure 1 Flowchart of the Navtech Radar PIDS Malfunction Diagnosis and Handling Process  
(Source: Processed by the Authors, 2025)

Figure 1 presents a flowchart that summarizes the entire diagnosis and handling process, from checking the radar status through the monitoring application, replacing the power supply, verifying the radar status's return to normal, through to checking and replacing the camera's RJ45 connector, up to the final test.

The repair was carried out by replacing the corroded RJ45 connector with a new connector, then reattaching it to the camera network cable using a crimping tool, following the standard cabling pin order. After the crimping process was completed, the cable was reconnected to the network switch, and a retest was performed, which showed the LED indicator on the switch lit green again, indicating the cable path was properly connected. Final verification was carried out through the monitoring application, which showed the Navtech radar could be monitored normally and the PTZ camera could once again follow the radar's commands as intended.

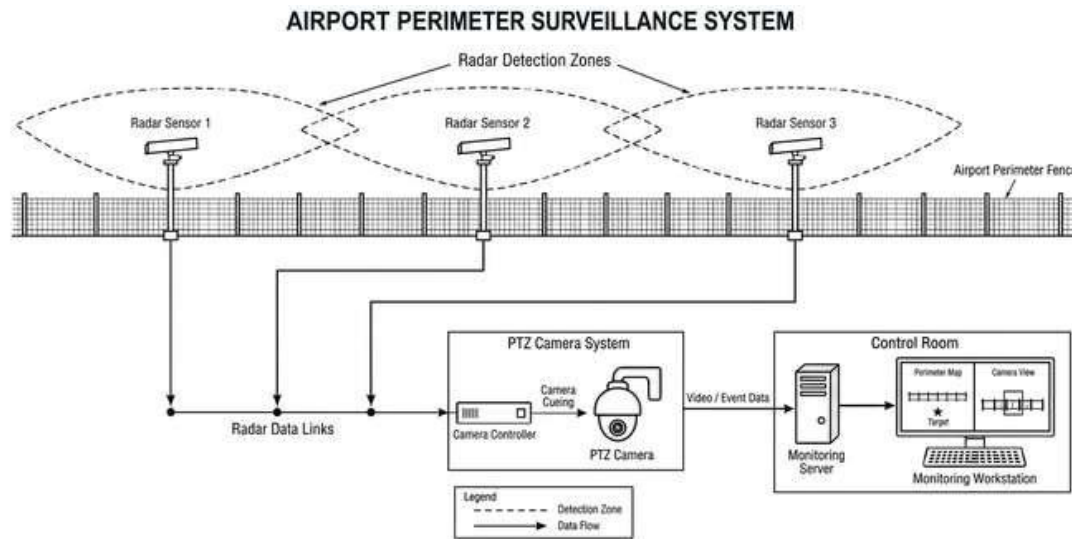
Figure 2 Conceptual Illustration of the Navtech Radar PIDS System in Airport Perimeter Security

Figure 2 presents a conceptual illustration of the Navtech Radar PIDS system, showing the placement of radar sensors along the perimeter fence together with their integration with the PTZ camera and the monitoring server, as a visual complement to the explanation of the system's working principle described in the previous section.
