## **Analysis of The Malfunction And Handling of The Access Control Intercom At An Airport Boarding Lounge**

The access control intercom is part of an airport's physical security system that connects Aviation Security (AVSEC) officers in the field with the On Duty (OD) monitoring room through a structured cabling network. On 24 January 2025, a malfunction was found in the intercom at Boarding Lounge Garbarata Way Gate B5, Terminal 1B (BL GW B5) of Soekarno-Hatta International Airport, where the device could not place a call to the AVSEC OD room. This article aims to analyze the cause of the malfunction and document the repair process. The method used was field observation and systematic troubleshooting, consisting of inspecting the intercom's condition, conducting a comparative test on a similar unit, and checking the LAN cable network using a LAN Tester. The inspection showed that the comparison intercom functioned normally, while the LAN Tester test on the faulty unit showed only two of nine pins lit (eight data pins and one ground pin), indicating a broken cable path. Further tracing found that the LAN cable on the intercom side was severed, which was attributed to termite dama

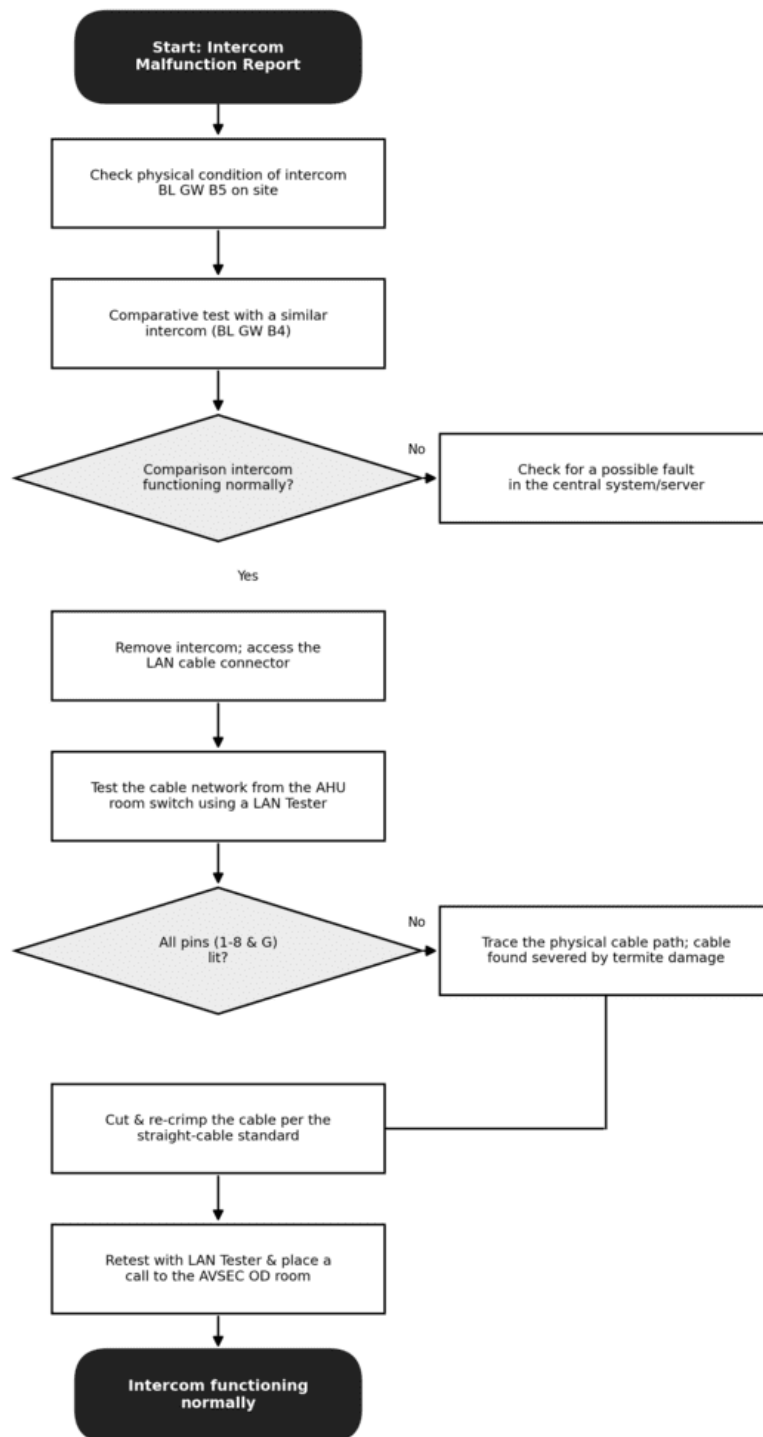
Figure 1 Flowchart of the Access Control Intercom Malfunction Diagnosis and Handling Process (Source: Processed by the Authors, 2025)

Figure 1 presents a flowchart that summarizes the entire diagnosis and handling process, from checking the physical condition and comparative testing, through cable-path testing with the LAN Tester, to the re-crimping process and final verification via a test call to the AVSEC OD room.

The repair was carried out by cutting the damaged section of cable, stripping the protective sheath, and arranging the eight internal wires according to the standard straight-cable pin order, then attaching a new RJ45 connector

using a crimping tool. After the crimping process was completed, a retest was performed using the LAN Tester, which showed all pins (1-8 and G) lit normally, indicating that the cable path was properly connected. The repaired cable was then reattached to the back of the intercom, and a direct test call was made to the AVSEC OD room. The test results showed that the call connected successfully, confirming that the intercom was functioning normally again.

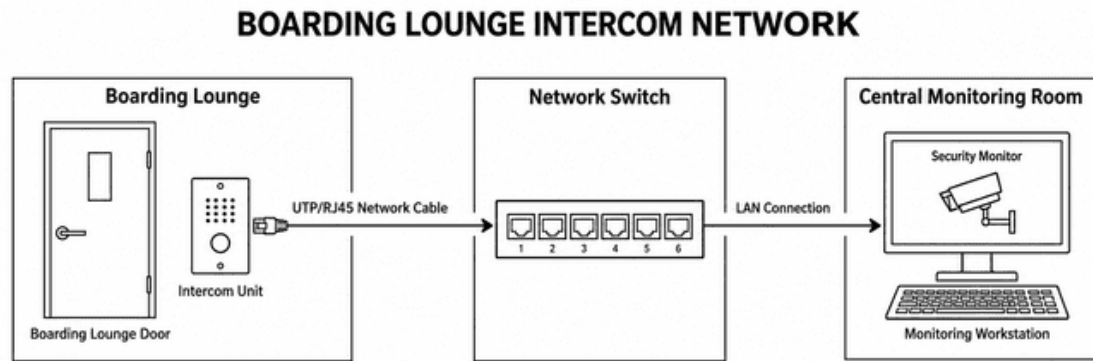
Figure 2 Conceptual Illustration of the Access Control Intercom System at an Airport Boarding Lounge

Figure 2 presents a conceptual illustration of the access control intercom system at a boarding lounge, showing the connectivity between the intercom unit, the UTP/RJ45 network cable, the switch, and the central monitoring room, as a visual complement to the explanation of the system architecture described in the previous section.

The access control intercom operates as part of an access control system integrated with a fingerprint reader, magnetic lock, and emergency break glass at a single access point. When an officer presses the call button on the intercom, an audio signal is sent through the data path to a network switch connected to the central server, then forwarded to the receiving device in the AVSEC OD room. The transmission medium used is Unshielded Twisted Pair (UTP) cable, category Cat5e to Cat8, with RJ45 connectors at both ends. There are two commonly used cabling methods: straight cable to connect different types of devices (such as intercom to switch) and cross cable to connect similar devices. An error in cable pin order or physical damage to any one of the eight wires inside the UTP cable can cause a complete signal-transmission failure, making testing with a LAN Tester -- which verifies the continuity of all data and ground pins -- a basic first-line method for isolating faults in a cable network (Bin Asrokin & Bin A. Rahim, 2018), commonly complemented by reflectometry-based fault localization (Idellette Judith et al., 2023) and physical-layer diagnosis (Xiong et al., 2025). Current intercom technology is also moving toward integration with Web of Things-based services, which enable remote monitoring of device status over the same data network used for the voice-communication path, so that connectivity faults have the potential to be detected earlier, before they affect call functionality (Huang et al., 2022). Intercom functions are also implemented over IP networks, as in VoIP-based intercom designs (Li et al., 2014), which makes the network cable part of the call path.
